MEDIA RELEASE

RELEASE OF FINDINGS FROM FINAL INVESTIGATION REPORT OF THE TAH CHING ROAD LIFT INCIDENT

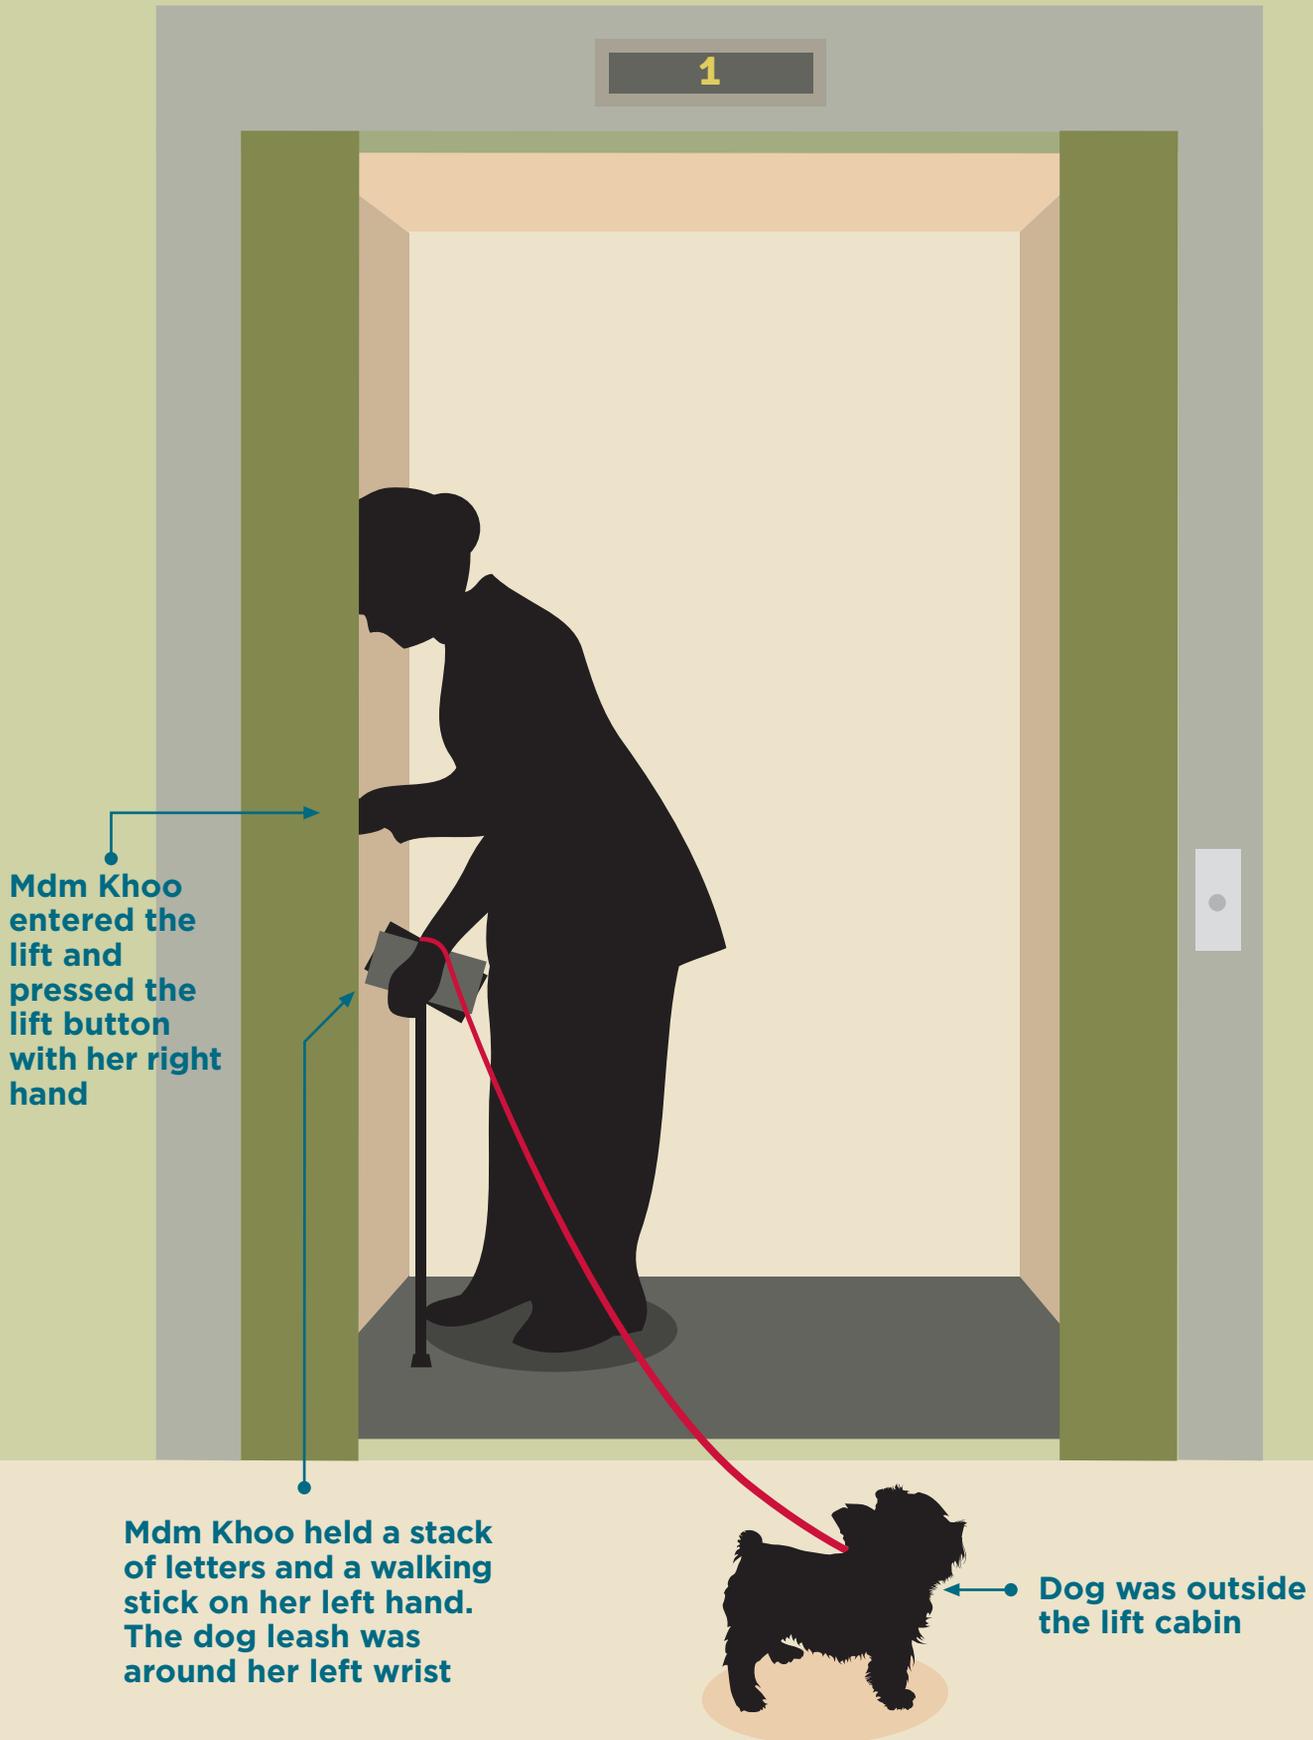
SEQUENCE 1

- a. Mdm Khoo entered the lift while her leashed pet dog was still outside at the first floor lift lobby. She pressed the lift button to the 16th storey and the 'Close' button. The dog was still outside the lift with the leash straddled across the lift doorway when the lift doors closed.

MDM KHOO ENTERS THE LIFT

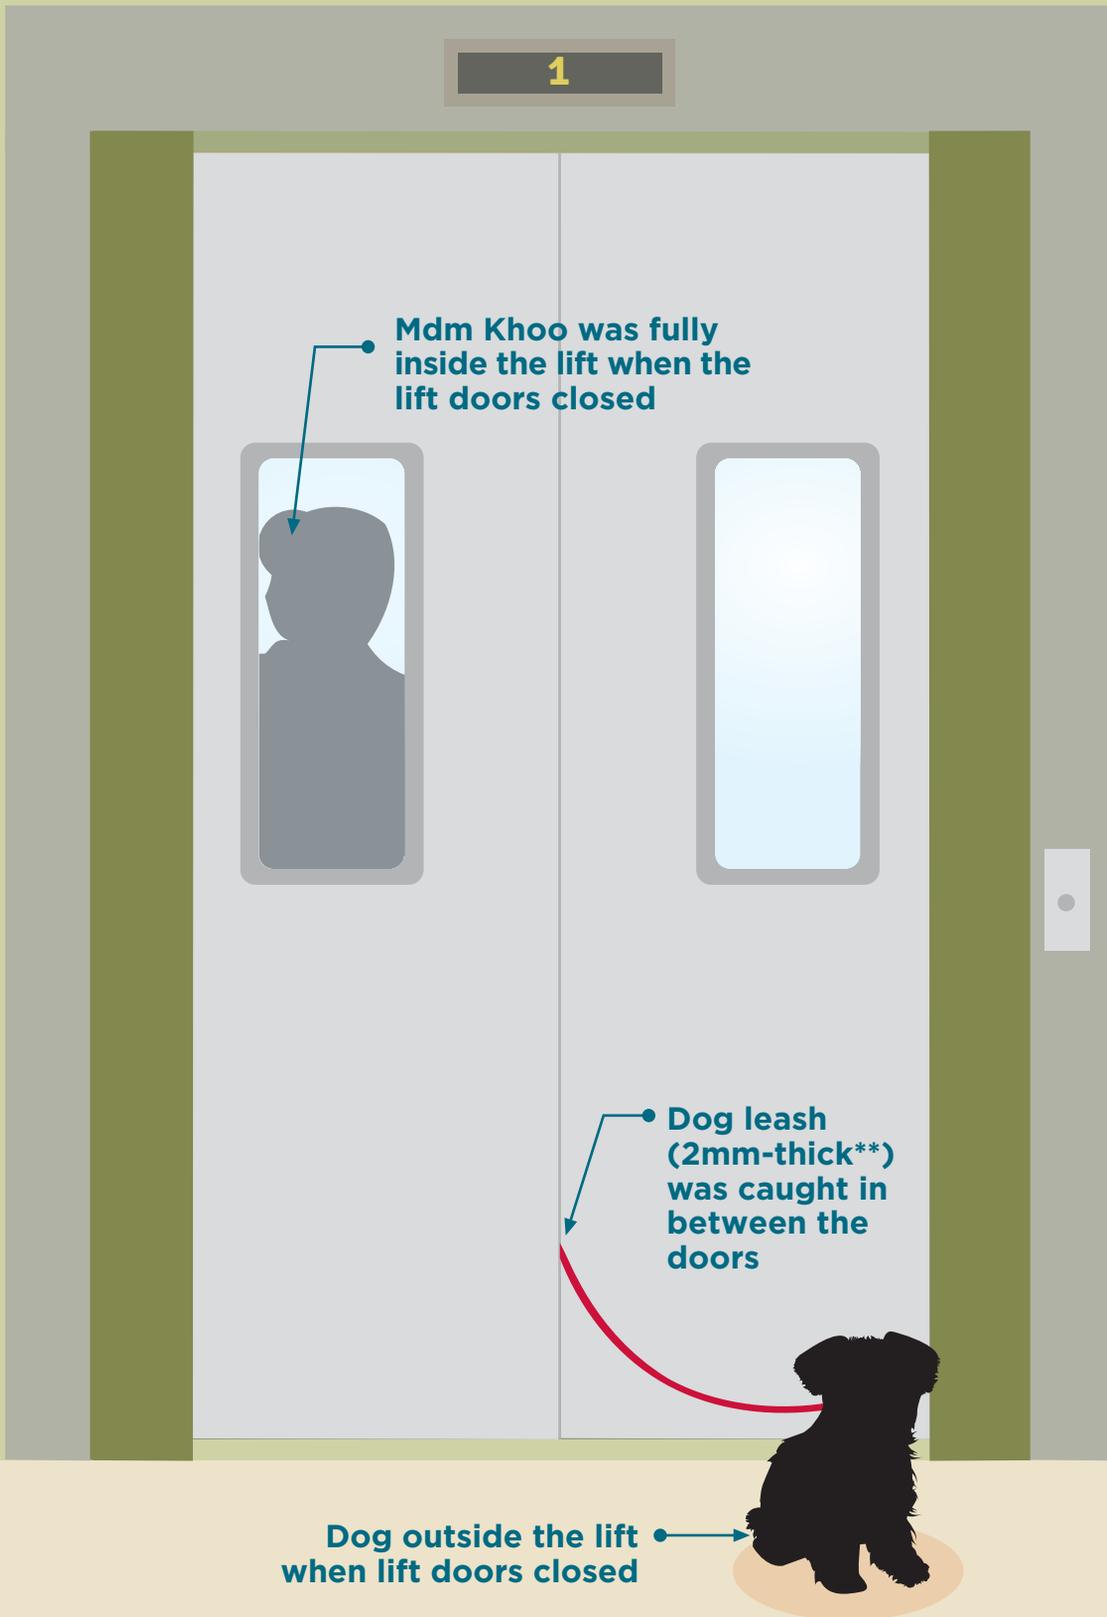
SEQUENCE 2

MDM KHOO IS IN THE LIFT

**Sensors on lift cabin doors are not designed to detect extremely small objects, such as a 2mm-thick dog leash

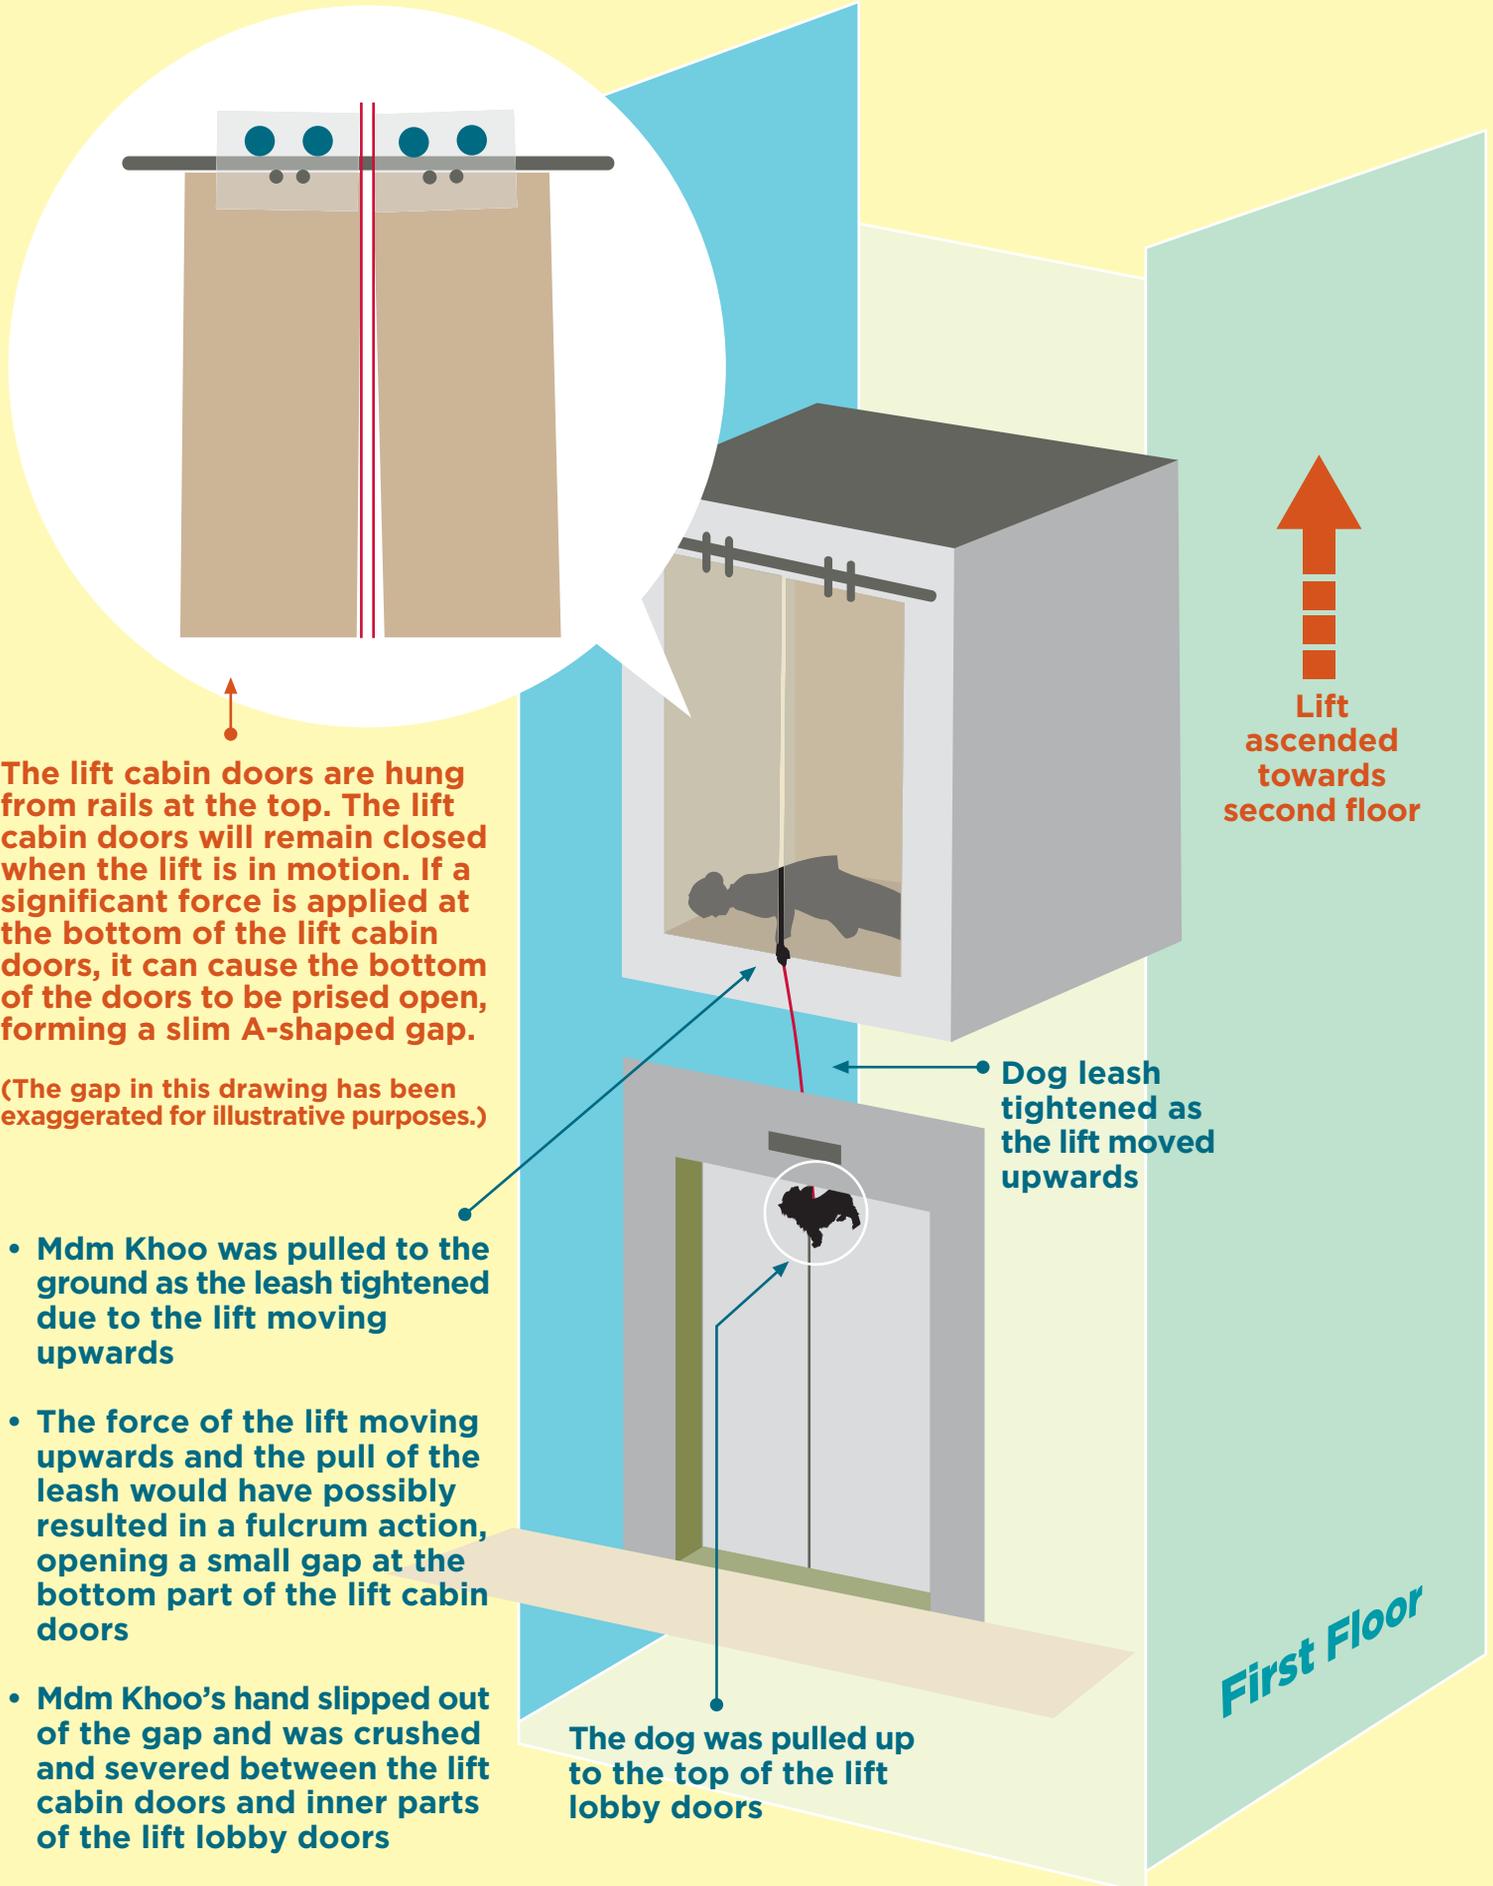
SEQUENCE 3

- b. As soon as the lift doors¹ closed, the lift's ascent tightened the leash that was looped around Mdm Khoo's left wrist. Mdm Khoo would have fallen onto the floor of the lift from the pull of the taut leash. The dog was also pulled upwards against the lift lobby doors till its harness buckle was caught at the top part of the lift lobby door.

- c. Based on the AE's simulations, it is likely that the pull of the taut leash could have caused a fulcrum action, opening up a small gap at the base of the lift cabin doors (i.e. the inner lift doors). As the lift continued to travel upwards, the strong force of the taut leash would have caused Mdm Khoo's hand to be pulled through this small gap at the base of the lift cabin doors.

- d. Her left hand, which was partially pulled through the lift cabin doors was crushed and severed between the lift cabin doors and the internal parts

LIFT ASCENDS
