# FAILURE OF CONTIGUOUS BORED PILE EARTH RETAINING WALL

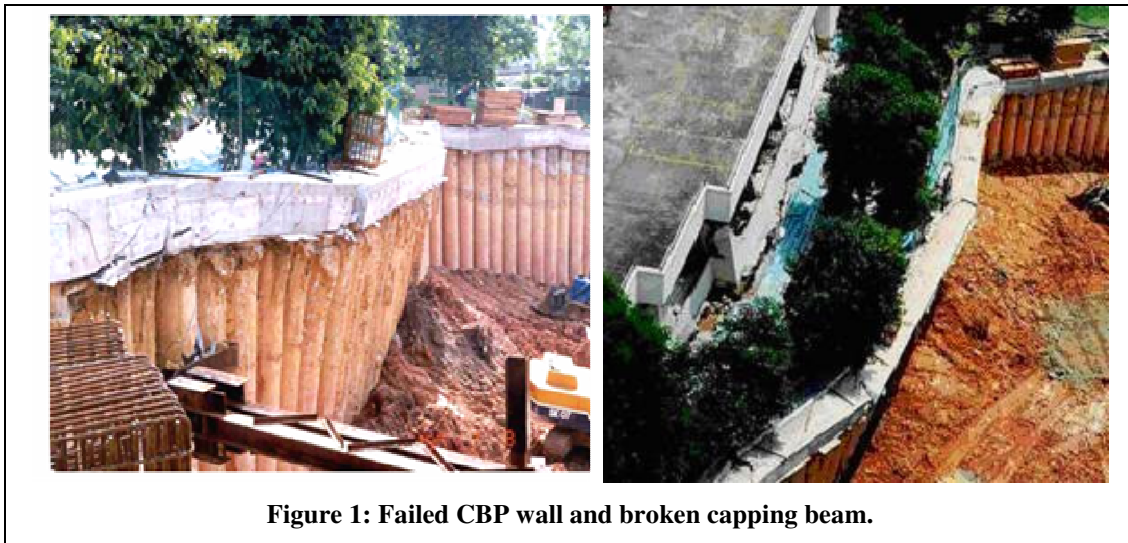
The design of the CBP wall called for one layer of struts to be provided at mid-level of the excavation. This was however not provided and the builder excavated the full depth to formation level without providing the proper struts. This left an unrestrained height of between 10 metres and 15 metres. The builder aggravated the situation by allowing water to collect at the base excavation, thus softening the soil which provides the passive resistance. After 5 days of continuous rain, the pressure behind the wall could have increased and the wall yielded. A capping beam tying the CBP at the top of the wall was sheared off.

**Figure 1: Failed CBP wall and broken capping beam.**

As there were buildings adjacent to the CBP wall, the excavated site had to be backfilled immediately. Non-stop round the clock backfilling operation was carried out over 7 days to restore the site back to its original level in order to stabilise the site condition.

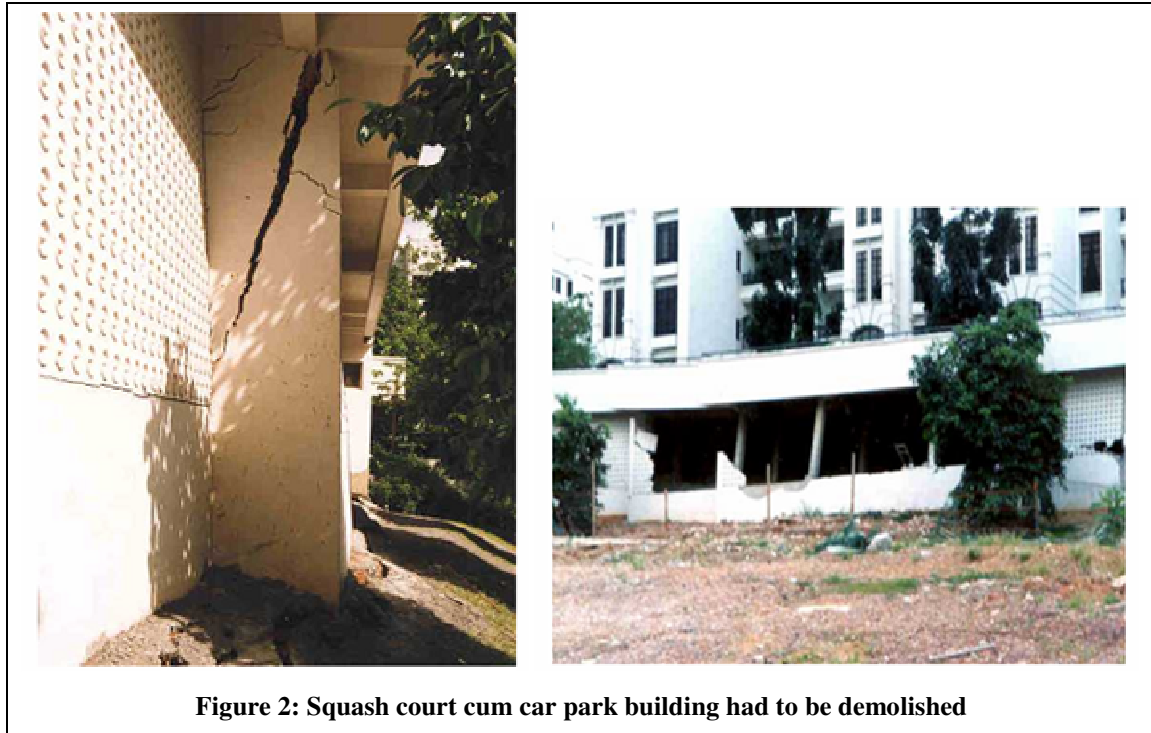
Excessive ground movement caused serious structural damage to the squash court cum car park building at the top of the hill. The building was closed and eventually demolished and re-built.
