FAILURE OF 2 METRE DEEP EXCAVATION FOR PILE CAP

This involves construction of a 4-storey flatted factory (with no basement) located between two existing single-storey terrace houses which were founded on small diameter bored piles.

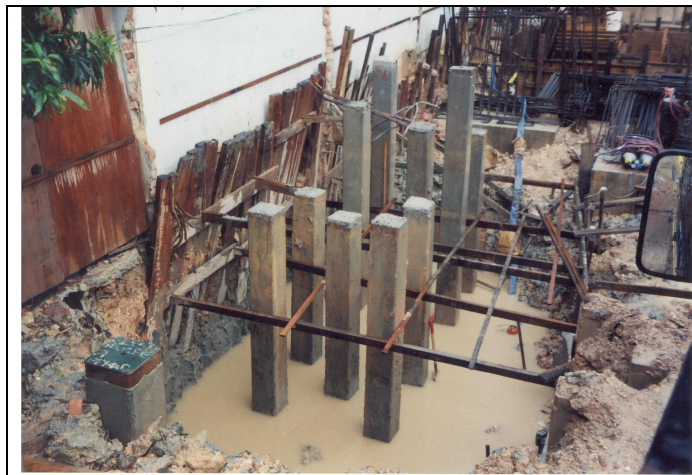
Timber planks were used to support a 2m deep excavation to construct a pilecap adjacent to an existing single-storey house. The ground condition was poor, comprising of soft marine clay and the timber planks to support the excavation was shoddily done.

Figure 1: Shoddy timber planks to support excavation for pile cap

- a) Every construction project, whether big or small should be given due attention.
- b) Properly designed temporary earth-retaining structures should be provided to protect the sides of the excavation, even for shallow excavation. The design should take into consideration the effects of inclement weather and presence of foundation of existing buildings.
- c) Extra precautionary measures should be taken when working close to existing building.

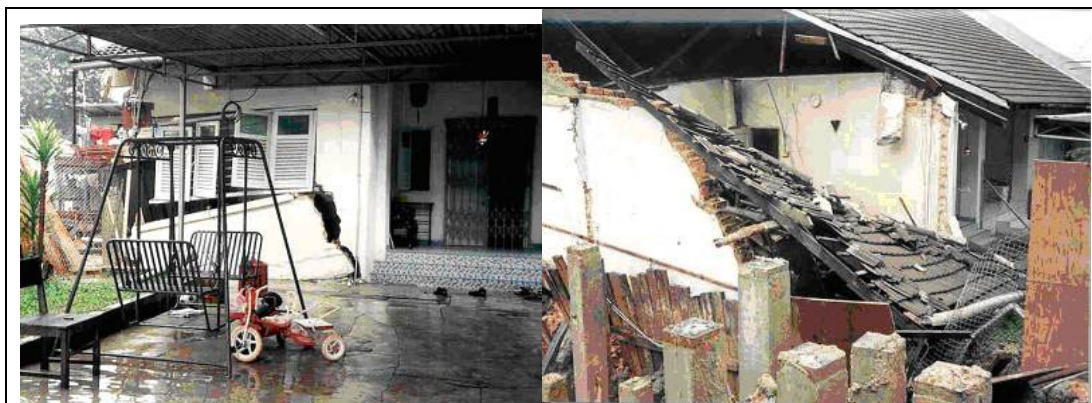
The timber planks were not effective in resisting the earth pressure and gave way, resulting in movement of the marine clay beneath the adjacent house. The ground movement cracked the small diameter bored pile supporting the adjacent house causing the entire front section of the adjacent house to collapse.

Figure 2: Cracking and collapse of adjacent single-storey house .
