TILTING OF NEWLY CONSTRUCTED CORNER-TERRACE HOUSE

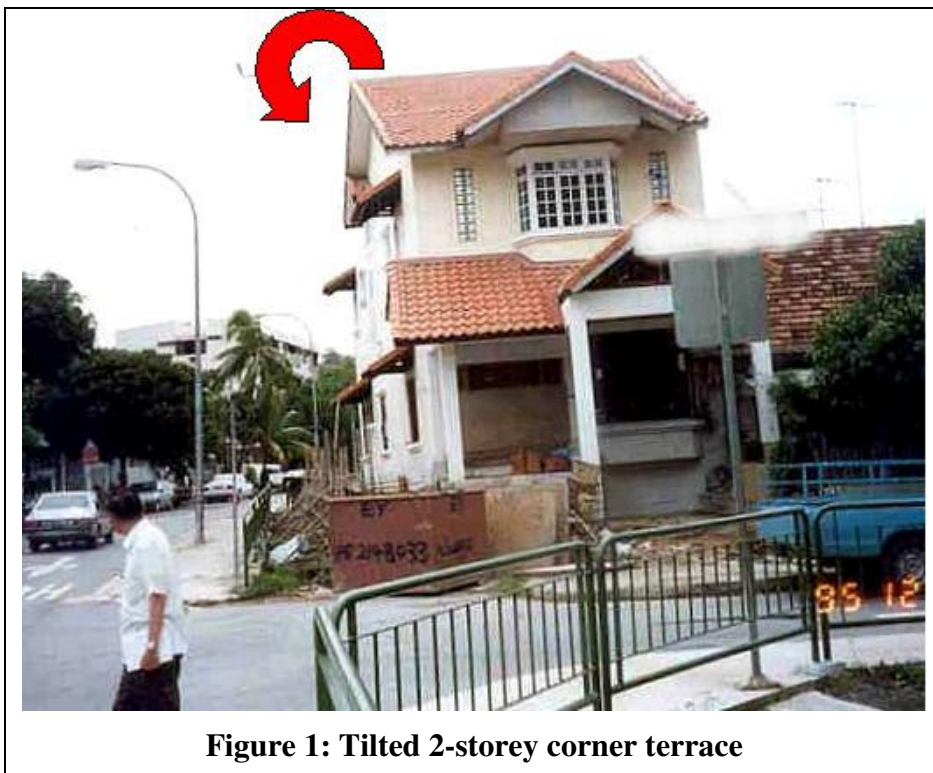
During the construction of the new building, the site was backfilled with earth to raise the platform level by 1.5m in order to comply with drainage requirements. However, the effect of this surcharge load from the backfill was not taken into account, resulting in excessive and uneven settlement.

When the building was nearing completion, it was found to have tilted, with the top of the building displaced laterally by 236mm relative to its base, and the building suffered a settlement of 655mm.

As the structural frame of the new house could become unstable, the newly constructed building was demolished and re-built. The adjacent house was also demolished and re-built.

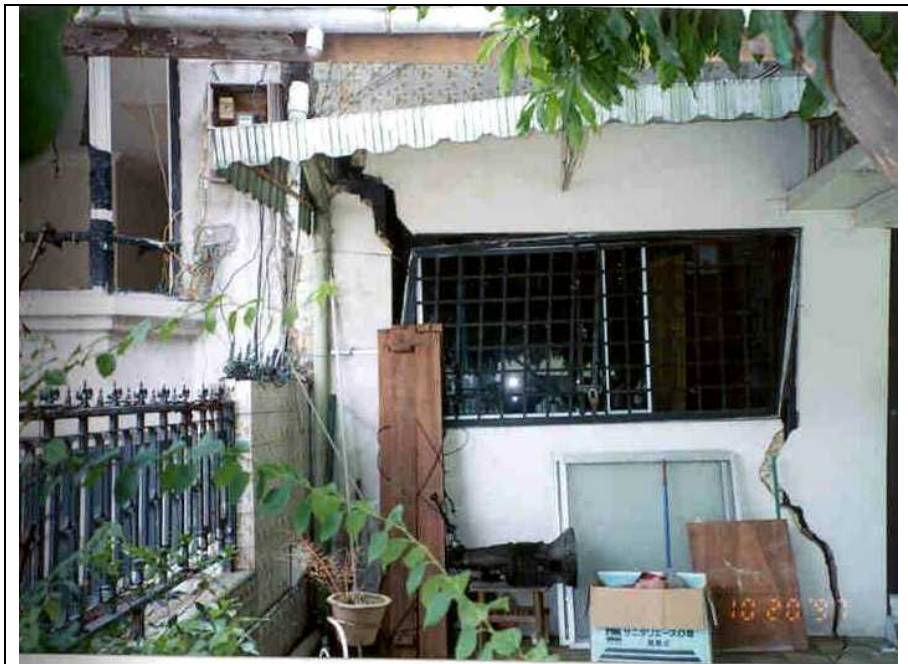
The adjacent unit of the terrace house was also affected by the rotation of the new building. Cracks measuring as wide as 200mm appeared on walls and beams of the adjacent house.

Figure 2: adjacent unit affected by tilt of the corner terrace
