# RM FORUM 2024

## SHARING OF KEY INSIGHTS FROM BCA INSPECTIONS

Building & Construction Authority of Singapore

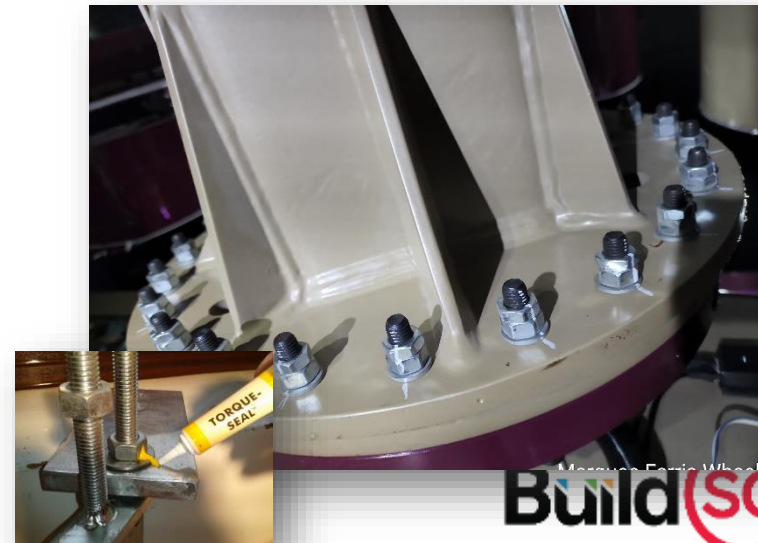
- Some structural bolts and nuts are missing torque seal markings.

- Each bolt should exhibit a single torque seal marking to ensure integrity.

- Provides visual indication if bolts has been loosened due to vibration or tampering.
- Failure in Structural Bolts → Catastrophic Incidents

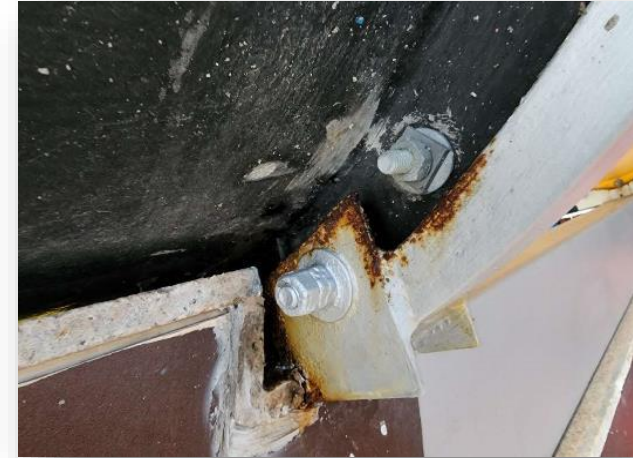
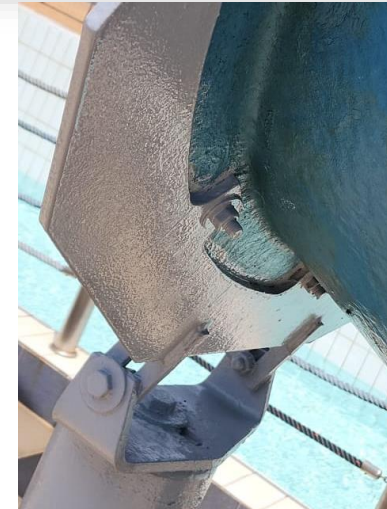
- Visible corrosion on critical components such as flanges and support brackets.

- Metal surfaces are inadequately treated against corrosion, with some merely painted over existing rust.

- It undermines the structural integrity of key components, **potentially causing abrupt and catastrophic failures.**
- Regular inspection and maintenance are vital to prevent corrosion-related accidents.

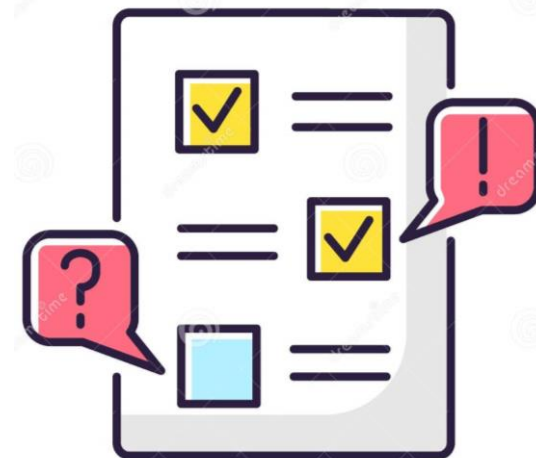
- Discrepancies between daily inspection checklists and the operational maintenance manual's guidelines.

- Essential parameters may be overlooked, while complex or unclear checks may lead to non-comprehensive inspections.

The **manufacturer's manual** states that the pump flow rate should be 2600 LPM to 3600 LPM, but the **checklist prepared by the Operator** instructs operators / technicians to verify an operating water flow rate of at least 1500 LPM.

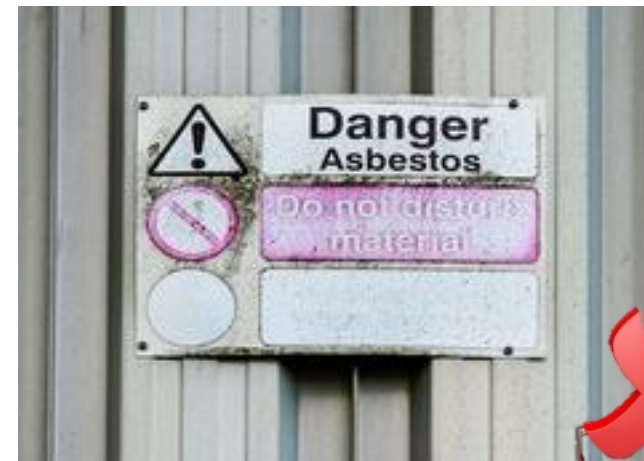
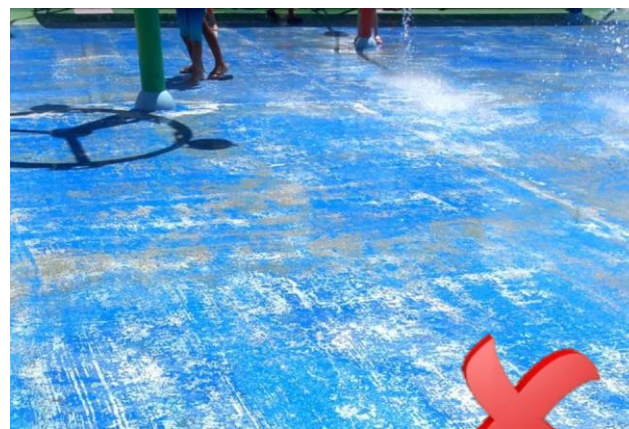
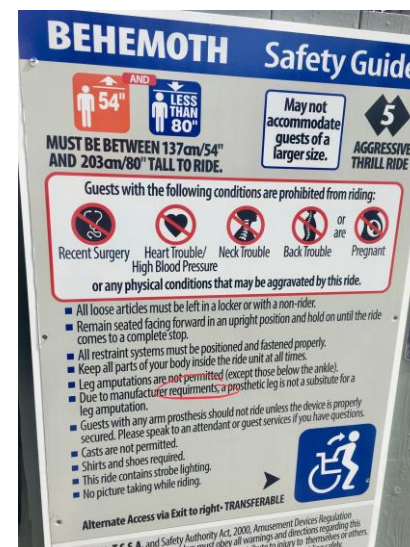
- Signages have faded due to weather exposure and have not been replaced in a timely manner.
- Floor signages faded.
- Worn anti-slip coating.
  - Could lead to potholes.

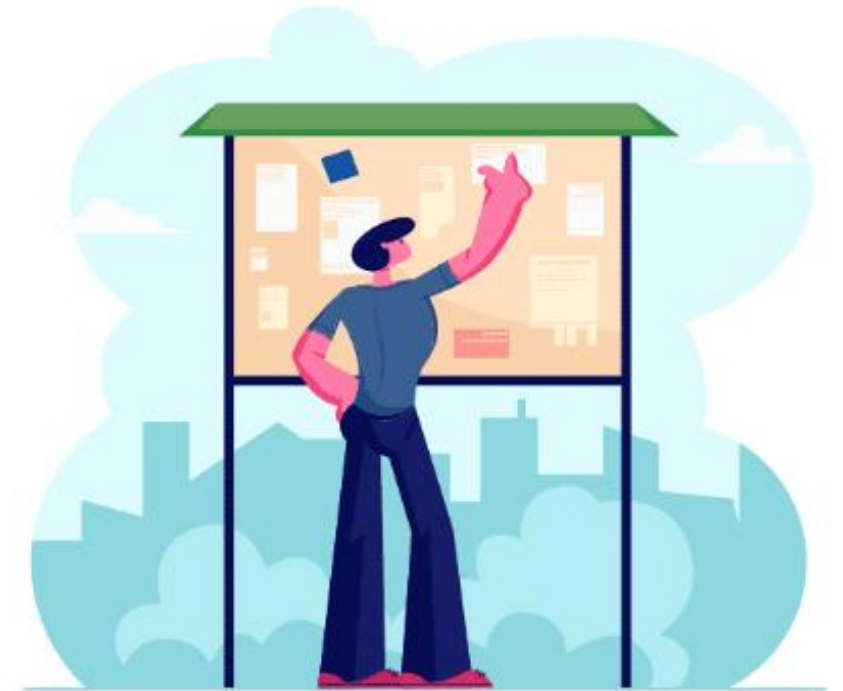
- Faded signages may lead to patrons unsuitable for the ride unknowingly participating, posing a risk to their safety.

- To effectively communicate restrictions and warnings, ensuring the well-being of all patrons.
- Regular maintenance of signage is essential for clear communication and safety compliance.

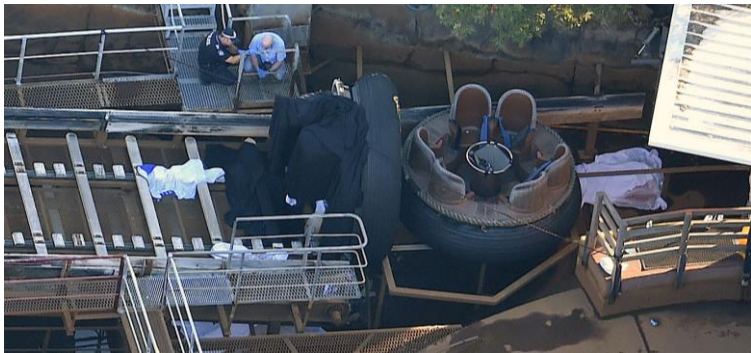
- The **direct cause** of the incident was a failed water pump, which resulted in the water levels reducing significantly, causing the raft to become caught on the rails.

4 individuals got trapped and lost their lives.
