Environmental Impact Study for Proposed Road Widening and Sewer Works along Lorong Lada Hitam

EIS Report

Prepared for
Building Construction Authority

28.06
2023

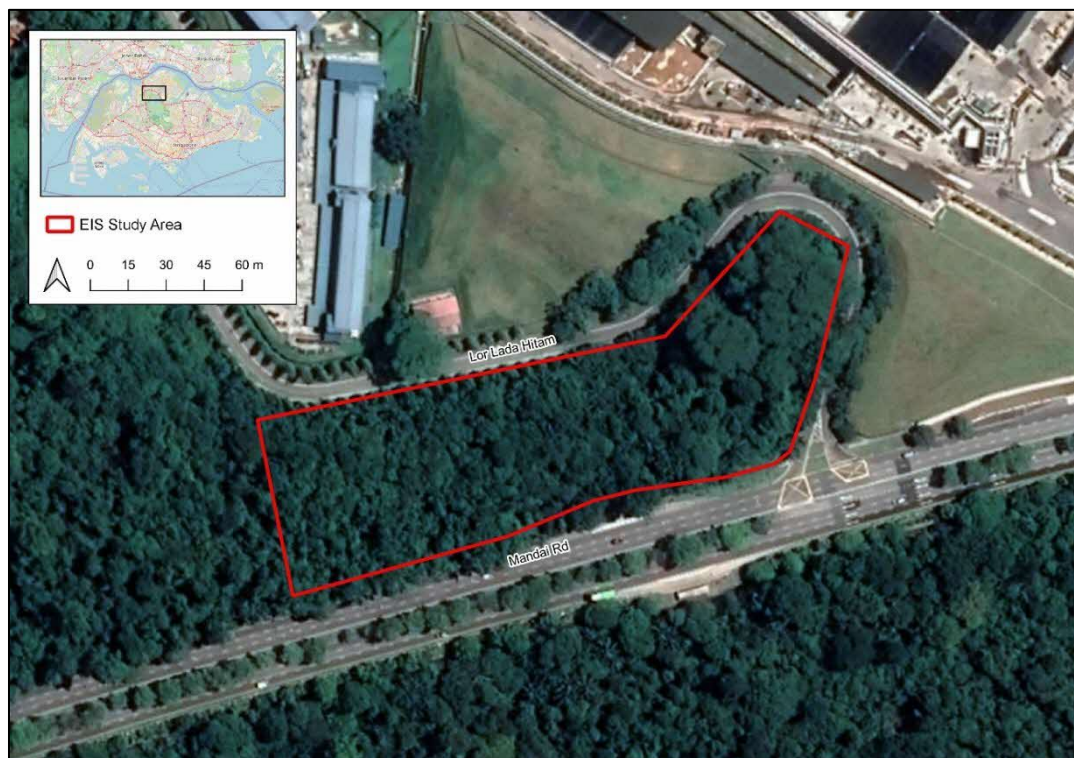
Figure 1: EIS Study Area boundary along Lorong Lada Hitam

The Study Area for this EIS is located in the Mandai area along Lorong Lada Hitam. It comprises approximately 1.45 ha of secondary forest that is surrounded by Lorong Lada Hitam to the north and east, Mandai Road to the south and a continuous forest patch to the west, as demarcated in red in Figure 1. The Site has been zoned as “Open Space” in the URA Master Plan 2019 (see Figure 2).

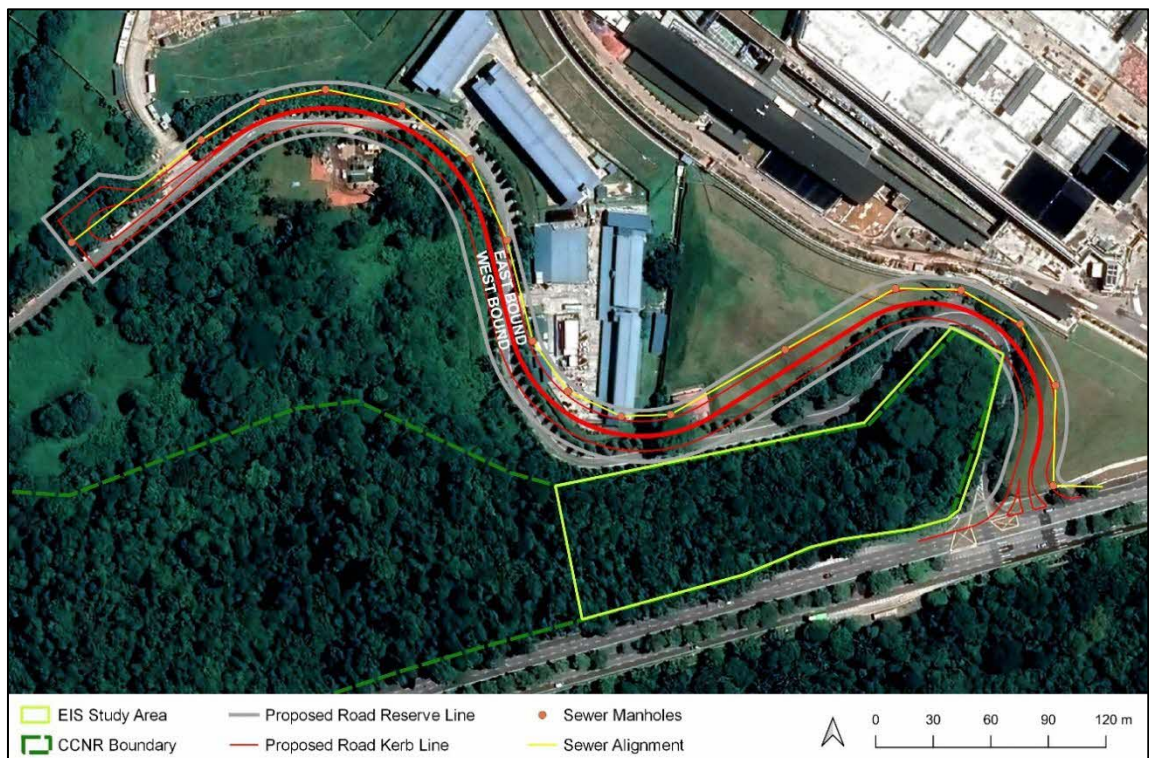
Figure 5: Proposed Road Layout of the Project

- Vegetation clearance;
- Excavation/earthworks;
- Access road construction;
- Asphalt works;
- Construction of kerb, drainage, traffic lights, cables/utilities, streetlights, and other features of a road; and
- Construction of sewer and associated manholes.

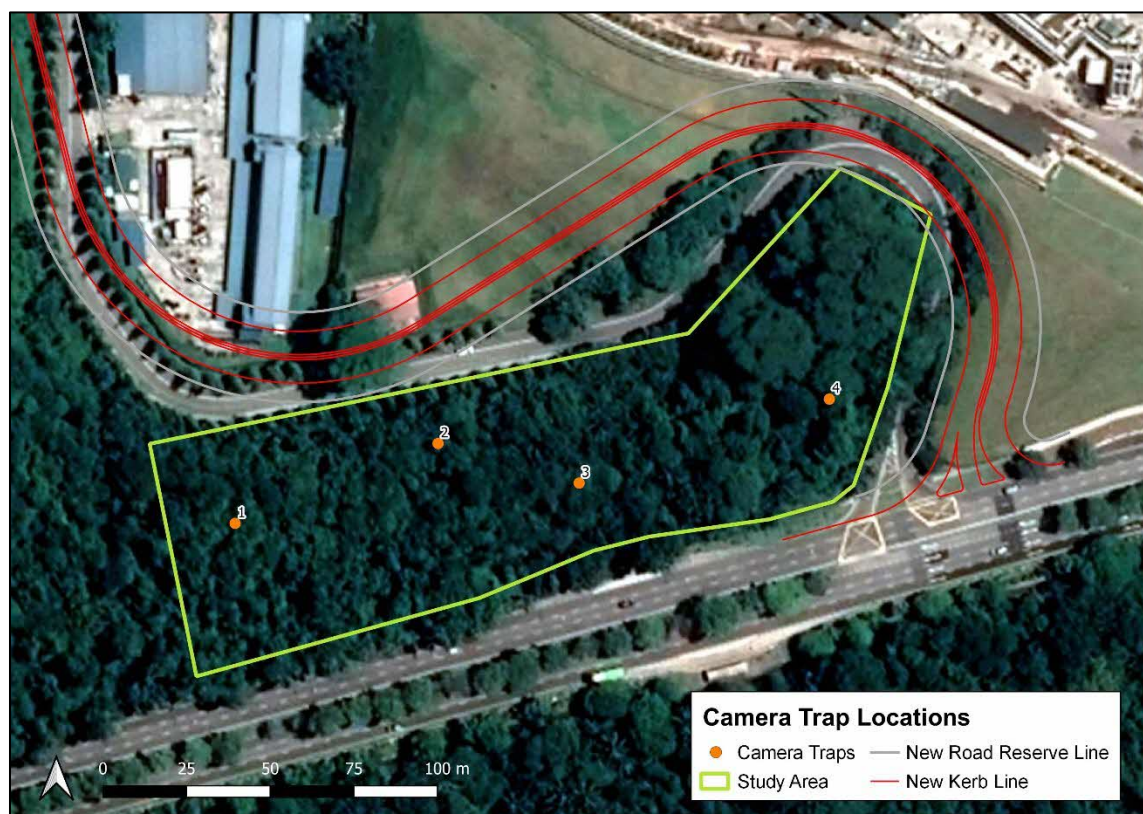
Figure 15: Camera Trap Locations

In addition to the transect surveys, four camera traps were placed in the forest to record animal activity in the absence of humans over the period of one month from 20th July – 19th August 2020. Camera traps were spread out within the forested study site at selected locations shown in Figure 15. The camera trap set-ups involved tying the camera using a cable-lock and a nylon strap around a tree to secure the camera trap. A small padlock was also used to lock the camera to prevent unauthorised access to data or theft of the device. The cameras were set-up approximately 20 cm off the ground and operated continuously for 24 hours every day, capturing 10-second videos of 720p resolution upon trigger, with a trigger interval of 30s. Species identification, abundance, and behaviour were noted from the footage.

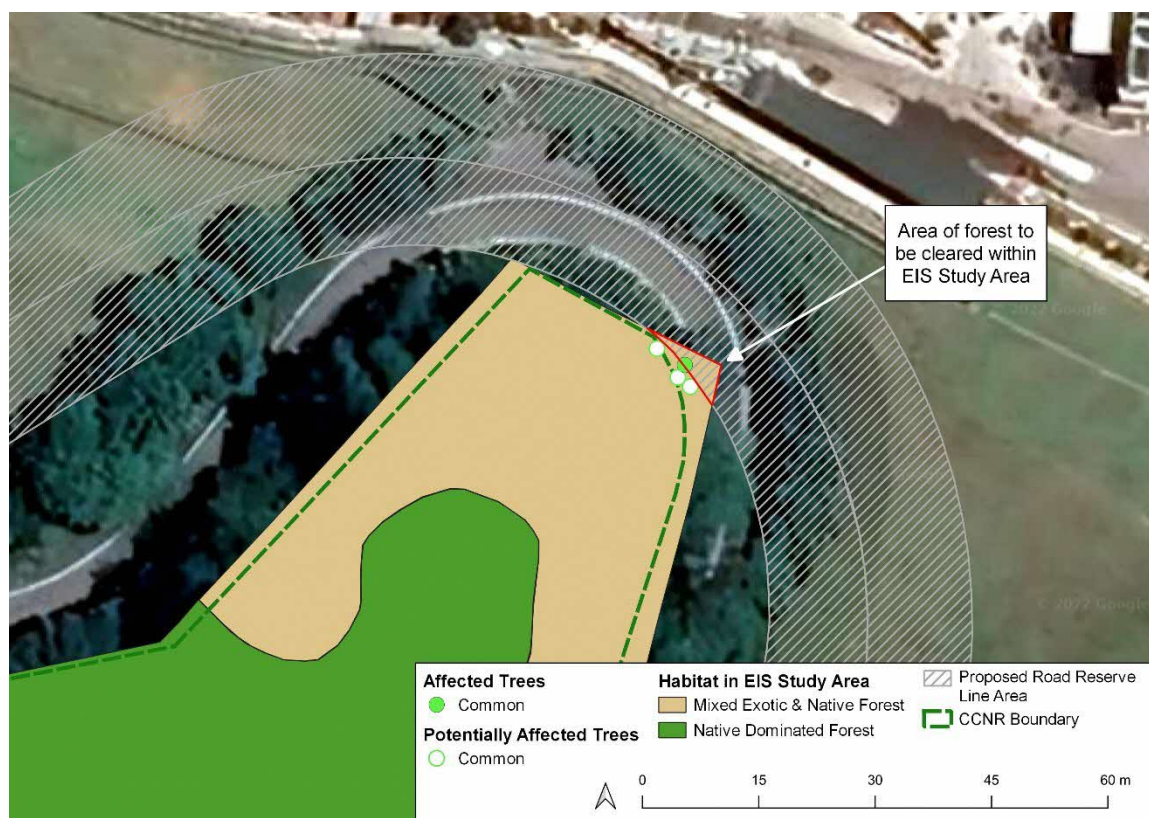
Figure 24: Potentially Affected Trees

Affected Habitat	Approximate Area Affected (m ²)	No. of tree loss (no. of CC species*)	No. of potentially damaged trees (no. of CC species)	Total no. of trees affected (no. of CC species)
Scrub (within nature reserve)	1.5	0 (0)	0 (0)	0 (0)
Exotic & Native Mixed Forest (outside nature reserve)	18	1 (0)	3 (0)	4 (0)

*Note: "CC species" refers to species of conservation concern, which means they either have threatened conservation statuses or are vital/keystone species.

Most of the study area is within CCNR, which is Singapore's core biodiversity conservation area. The CCNR is considered a rare habitat in Singapore and is of high ecological importance. However, the study area is separated from the core CCNR forest by Mandai Road. As seen in Figure 17, there are patches within this forest, especially in the native dominated habitat, that has a higher density of native species as compared to naturalised and exotic species. However, there is also a large patch that is dominated by rubber trees, as well as patches of scrub. It should be noted that for the areas where vegetation is expected to be cleared lie

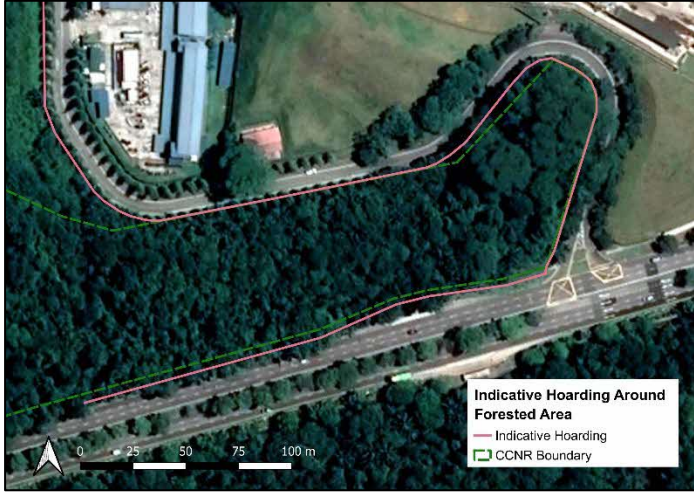
<p>Figure 25: Indicative Hoarding around Forested Areas</p> <ul style="list-style-type: none"> Keep and submit all records of any roadkill to the EMMP consultant. 					
12	Waste Management	<ul style="list-style-type: none"> A waste management plan should be created that provides further technical details and implementation methods for all measures highlighted in this Table, adopting the principles of Reduce, Reuse, Recycle; All ECB used in the project shall be plastic-free, wildlife friendly and fully biodegradable; The contractor should ensure that information in the waste management plan that is applicable to individual site workers is disseminated to them; In order of preference (1 most preferable), waste should be disposed of in the following ways: <ul style="list-style-type: none"> Minimise initial waste generation wherever possible; Items for waste disposal should be re-used if safe and appropriate (i.e. not hazardous waste containers); and When not re-used on Site, waste should be taken to an off-site recycling facility; Non-recyclable waste should be disposed of appropriately in line with local regulations at a pre-defined off-site location. 	<ul style="list-style-type: none"> Contractor ECO 	x	x		Environmental Protection and Management Act Environmental Protection and Management (Trade Effluent) Regulations Code of Practice on Surface Water Drainage Code of Practice on Surface Water Drainage
