WHAT YOU NEED TO KNOW ABOUT..... PREFABRICATED BATHROOM UNIT (PBU)

BCA Buildability Series

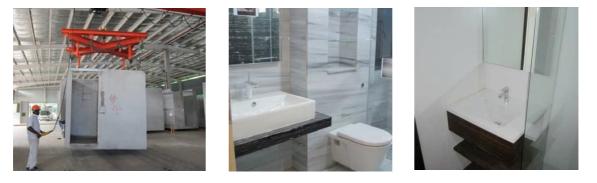
The prefabricated bathroom unit (PBU) is constructed using dry installation method. The unit is pre-assembled in factory and delivered to site for installation.

This brochure will focus on fully pre-assembled PBUs. All finishes and fittings are done in the factory to achieve better quality and productivity.
