EARTH SLIP AT EXCAVATION SITE

Type of building work

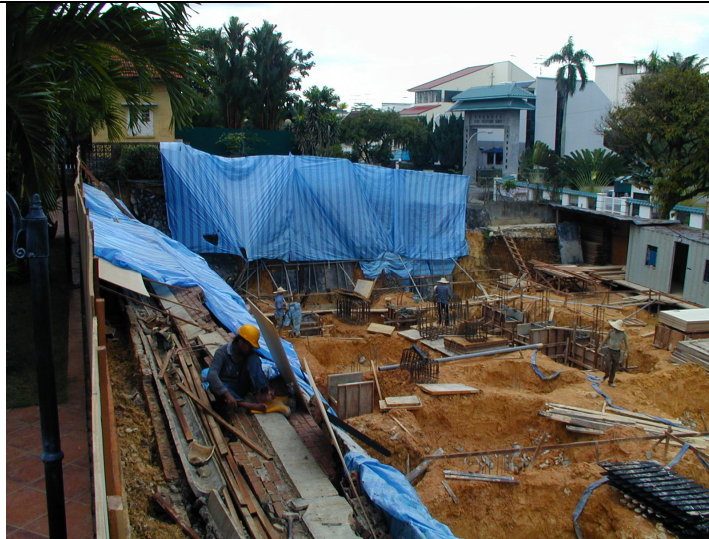
The project involves erection of 4 units of 2-storey terrace house each with a basement. There was a 2.3m high earth retaining rubble wall at the boundary with the adjacent house. An open-cut with a slope was adopted for the excavation, and the slope was protected with a layer of 300mm thick mass concrete.

Figure 1: Excavation was carried out near the base of existing rubble wall

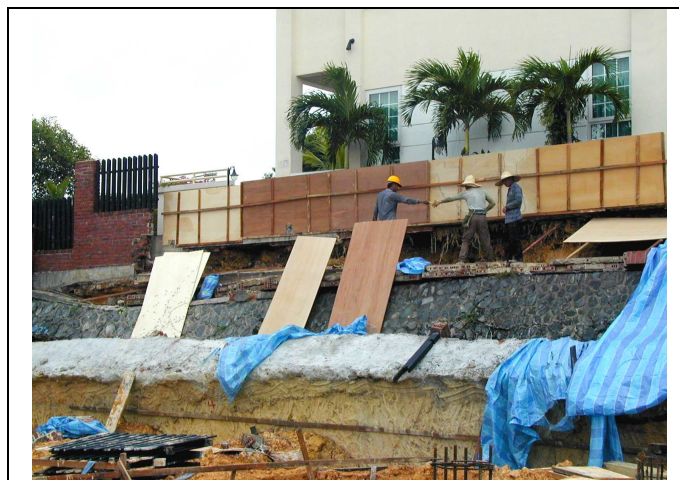
When the site was cut down by 2.7m, a slip developed causing the existing rubble retaining wall to rotate and tumble down. The boundary wall of the adjacent house and the perimeter drain were also damaged.

Figure 2: The failed rubble retaining wall

Investigations revealed that the contractor had excavated for pile caps along the whole length at the foot of the slope, instead of a small stretch at a time. The design also did not take into account weakening of the soil due to rain.

- a) Precautionary measures must be put in place to prevent deterioration of slope due to weather.
- b) If the design necessitates a particular sequence of construction (such as excavation of pile cap in a specific sequence), this should be clearly shown on the drawings.
- c) The professional engineer should visit the site regularly to confirm that the construction sequence is in accordance with the design assumption, and the site supervisor should be vigilant to ensure that precautionary measures are put in place.
- d) If the excavation is carried out near the base of an existing earth retaining structure, a check on possible reduction in passive resistance must be carried out.
- e) Soil parameters should take into account the most severe situation.
- f) Design must cater for loading condition due to over-excavation.
