ROOF TRUSSES COLLAPSE DURING CONSTRUCTION

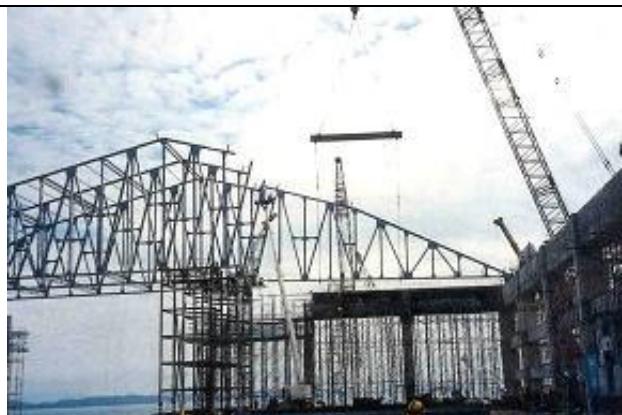
The top and bottom chords and the longer diagonals of the trusses were made up of double angles connected back to back. As the span of the truss was long (59m), the height of the truss at the mid-span was also large, standing at 10.8m high. A single truss when installed would stand up as a rather slender element. Erection of the trusses did not commence from one of the gable end walls, and as a result the first 3 adjacent trusses that were erected were braced against each other instead of being braced against a rigid gable end wall. Temporary supporting towers were used as intermediate supports to facilitate erection.

Figure 1: Erection of the first 3 trusses

- d) Lateral and diagonal restraints for erection of trusses should be connected to sufficiently rigid supports, for example, rigid reinforced concrete frame at the gable end of the building.

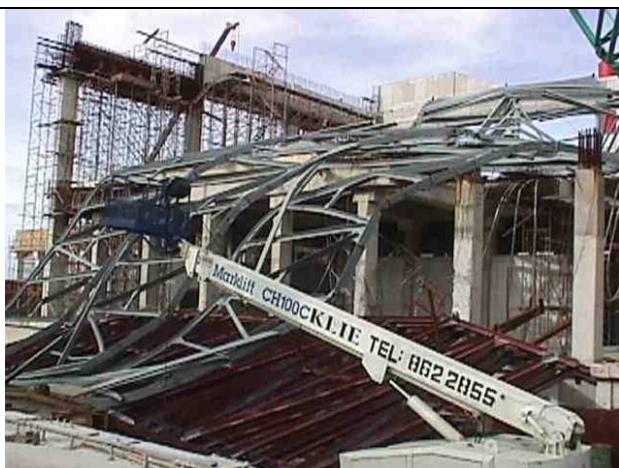
After the first 3 trusses were erected, the contractor removed the temporary supporting towers situated at mid-span of the trusses. The 3 trusses collapsed shortly after that and killed two workers and injured few others.

Figure 2: Collapsed trusses

On completion of the erection process, some of the purlins and tie beams near the temporary supporting towers were not installed so as to provide a clear space for lifting. Temporary diagonal bracings were also not used to provide effective lateral stability and torsional rigidity to the trusses. The tight space available for the removal of the temporary supporting towers, coupled with the use of a crane mounted on a floating barge, warrant skill, precision, and coordination between the crane operator and the personnel giving instructions in order to avoid accidental lateral loads.

- a) Although a large truss member could be designed in the same way as any typical truss, PE should take cognizance of its size effect as the handling and performance of a long and high truss (such as 59m long and 10.8m high truss) could be very different from an ordinary truss. Issues such as lateral stability and torsional rigidity becomes very crucial during the various stages of fabrication and erection.

- c) When long slender structural steel members are subject to compression, presence of bracing members are very critical, especially for compound angle members as their performance depends very much on the effectiveness of battens as well as the presence of effective lateral bracing elements.

- e) All temporary supports and bracings should also be designed for any incidental lateral forces during the construction.
- f) Connection details should be carefully detailed and constructed to reflect the design intention, so as not to induce unnecessary forces and moments which are not accounted for in the design.

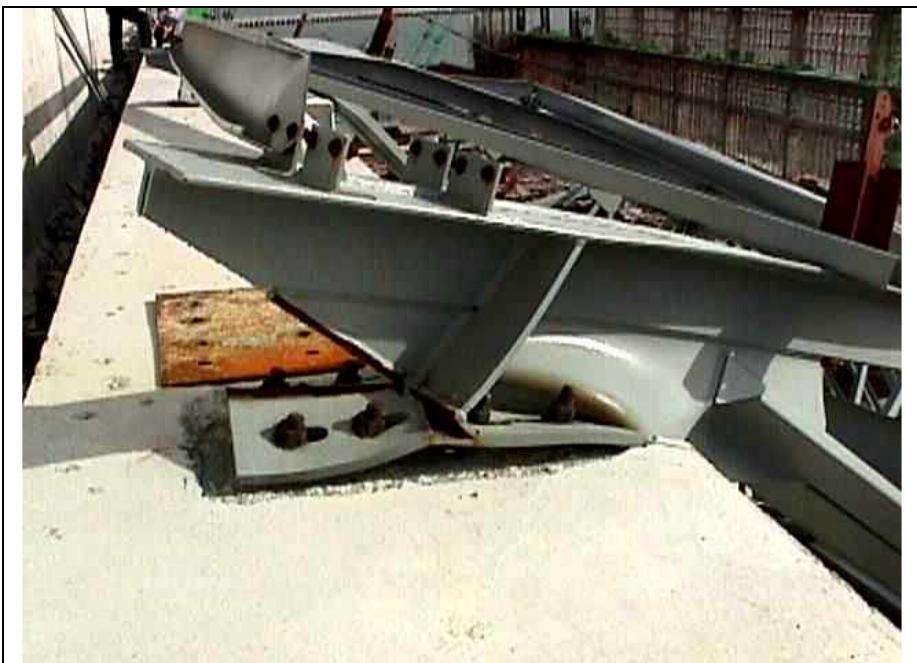
While the intention of the knee-joint support is to have a sliding joint, the 8 numbers of holding-down bolts at the support might not have allowed this to be achieved, and the joint was likely to behave as a pin-jointed support.

In view of the large height of the truss and possibility of eccentric loads and uneven distribution of stresses at the joints (from pattern loading due to construction sequence), members at the support could warp easily and invalidate the assumption of plane sections remaining plane.

Figure 3: Knee-joint at support. The angle cleats to hold purlins were not continuous.

As most of the key truss members were long and made up of double angles connected back to back, battening of compound compression members had to be carefully addressed in the design to meet code requirements on slenderness ratio of the members. Angle cleats used to hold the purlins were not provided as a continuous piece to tie up the back-to-back compound members together. Thus, the intention to make use of these cleats as battens was not properly carried through. As a result, the top chord members which were in compression were insufficiently battened.
