# TEMPORARY EARTH RETAINING STRUCTURES/EXCAVATION WORKS FAILURES

## Type of building work

This involves construction of a 6-storey building with a basement. The temporary earth retaining wall proposed for the construction of the basement was that of cement-soil-mix jet grout wall, with excavation and strutting to be done in stages.

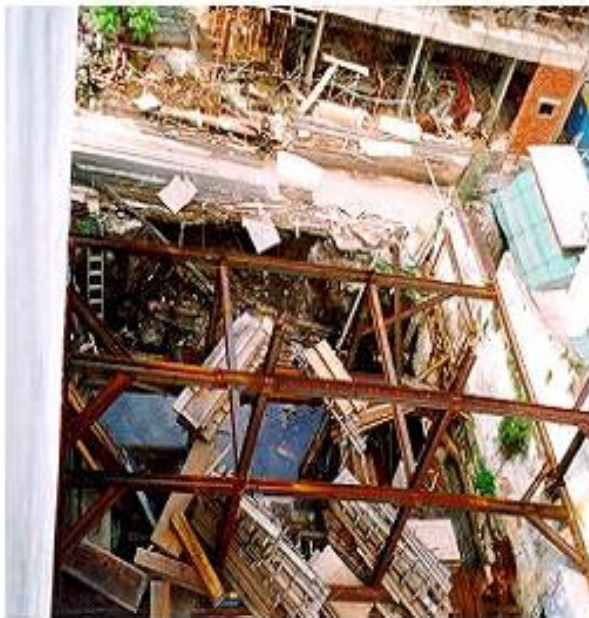
Instead of carrying out the excavation and strutting in stages, the builder excavated the site with a vertical cut to the full depth of 4m without the struts or earth berm on one side of the excavation as proposed. The jet-grout wall on the side which was not strutted collapsed and brought down with it the adjacent road pavement which was stockpiled with building materials. The other 3 sides of the excavation where struts were installed did not collapse.

**Figure 1: Excavation site with struts on 3 sides**

- a) Sequence of excavation and installation of struts must be clearly shown on the construction drawings and followed closely. Any adjustments to be made to suit site constraints must be checked and approved by the PE who carried out the design prior to execution.
- b) There must be no stockpiling of materials next to the excavation, unless the temporary wall has been designed for the surcharge loading.
- c) Site supervisor and QP must be vigilant in their supervision to ensure that works are carried out in accordance with approved design. Non-compliance with

approved design, including the sequence, which could compromise safety should be reported to BCA.

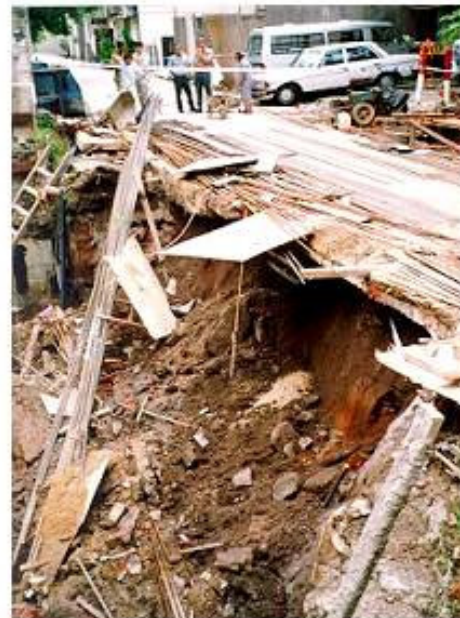
**Figure 2: Collapsed part of excavation**
