TEMPORARY SHEET PILE EARTH RETAINING WALL CAUSING EXCESSIVE GROUND MOVEMENT

Type of building work

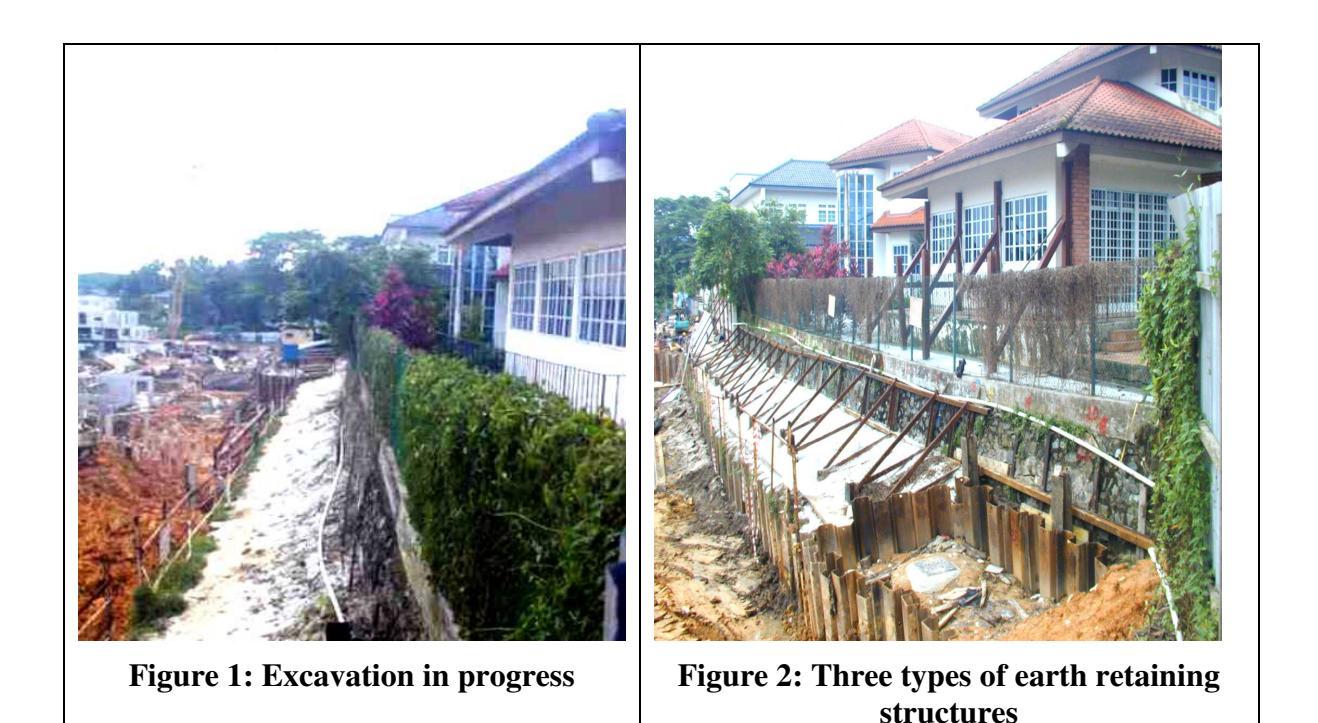
This project comprised a cluster housing development with a basement. The difference in level between the excavated site for the basement and the adjacent properties was 8.5m. A combination of existing 2.5m high rubble retaining wall, earth slope and sheetpiles with two layers of inclined struts were adopted as earth retaining system for the excavation. The earth slope between the top of the sheetpiles and the existing rubble retaining structures was protected with lean concrete.

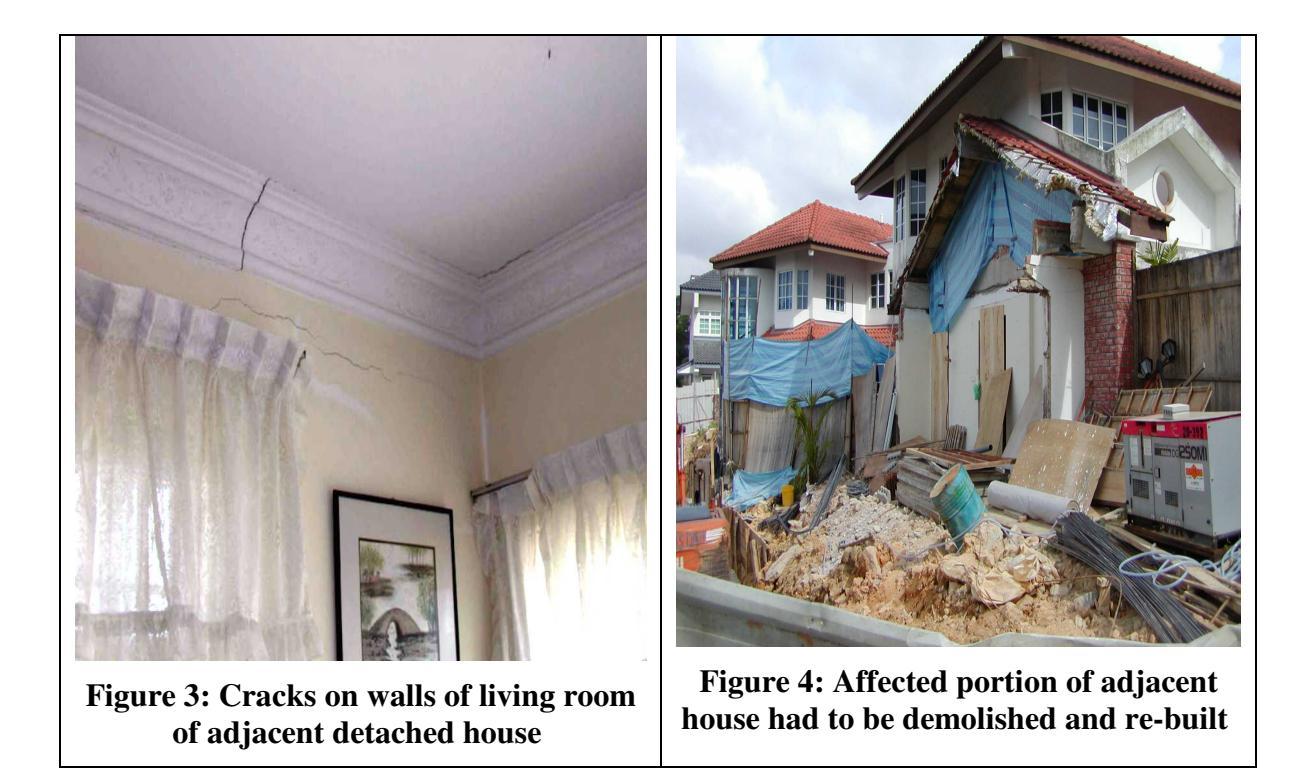
Excessive movements caused cracks to develop on walls, floors and ceilings at various locations in the adjacent detached house. Immediate safety measures had to be implemented which included backfilling of gaps behind the sheetpiles with concrete grout and installation of additional struts to reinforce the existing retaining wall and prevent further soil displacement.

The affected portion of the adjacent building had to be demolished eventually and re-built to its original condition.

- a) The impact of the soil movement on the stability of adjacent properties, such as old rubble retaining wall and existing building founded on shallow foundation, which are sensitive to ground movements should be studied very carefully prior to the selection of the temporary earth retaining system. A more rigid temporary retaining structure should be adopted.
- b) The additional surcharge due to presence of slope adjacent to the temporary earth retaining wall and the shallow foundations of the adjacent buildings must be considered in the design of the temporary earth retaining structures.
