# Guidelines on Periodic Facade Inspection

Version 1.1

March 2022

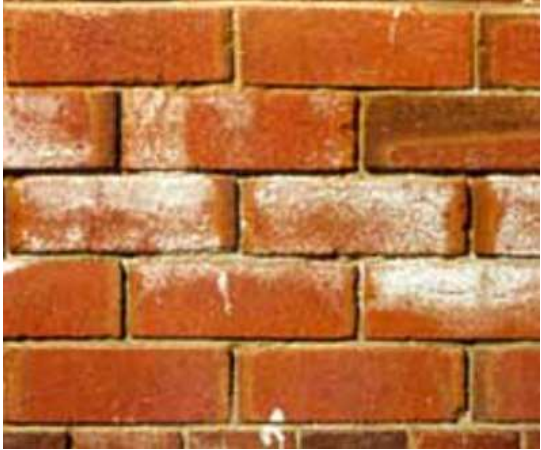
<p>Cracked concrete panel [Source: BCA file]</p>	<p>Efflorescence on brick wall [Source: <a href="https://www.diydoctor.org.uk/projects/efflorescence-causes-and-cures.htm">https://www.diydoctor.org.uk/projects/efflorescence-causes-and-cures.htm</a>]</p>

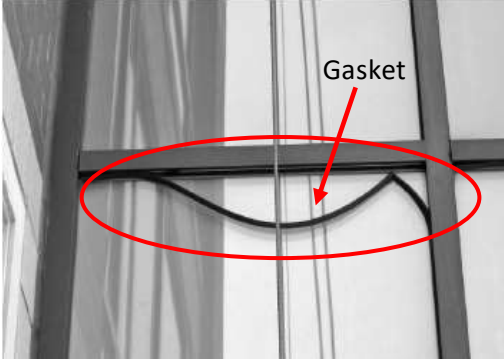
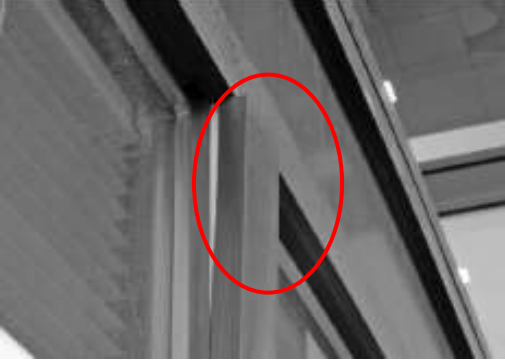
<p>Loose gasket [Source: Hoffmann Architects Journal, Vol. 29]</p>	<p>Dislodged mullion capping [Source: Hoffmann Architects Journal, Vol. 29]</p>

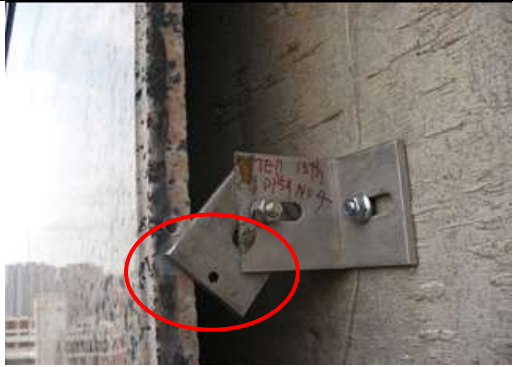
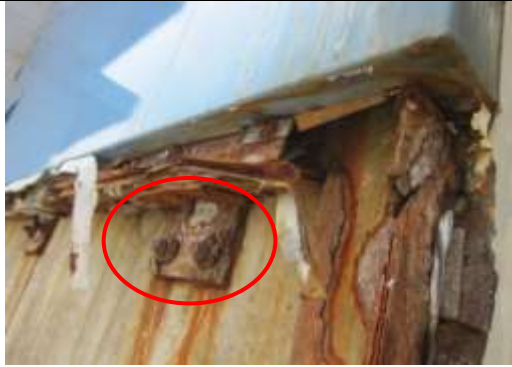
Missing pin in stone cladding connection [Source: BCAA course notes]	Corroded bracket in cladding system [Source: BCAA course notes]

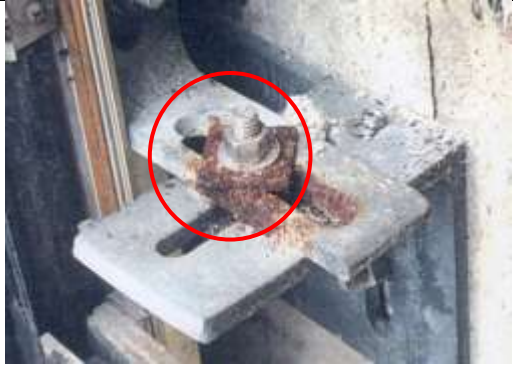
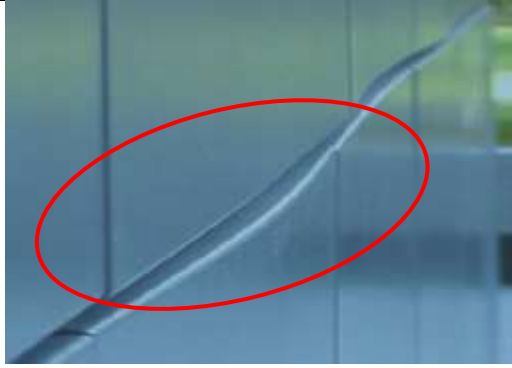
Corroded bracket in cladding system [Source: BCAA course notes]	Deformed or warped of cladding panels [Source: BCAA course notes]

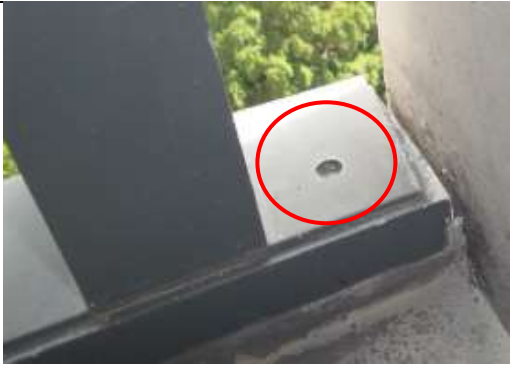
Missing connection on screen wall [Source: BCA file]	Loose connection between screen wall and support [Source: BCA file]

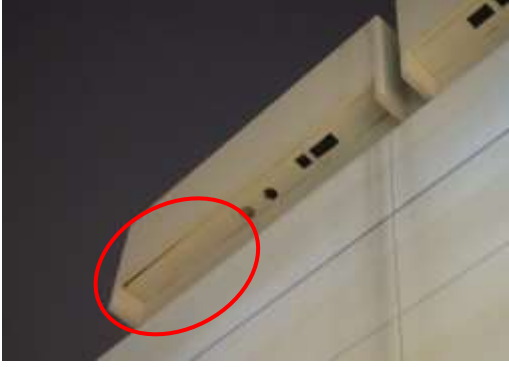
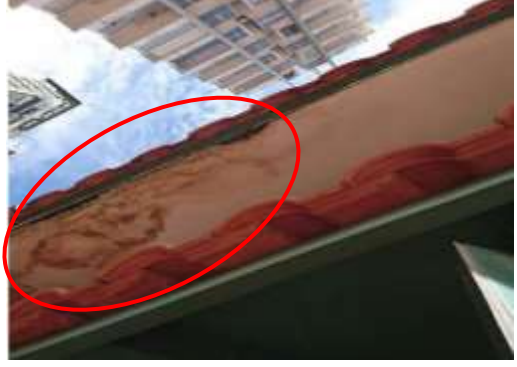
<p>Loose ceiling boards [Source: BCA file]</p>	<p>Water stain on ceiling boards [Source: BCA file]</p>

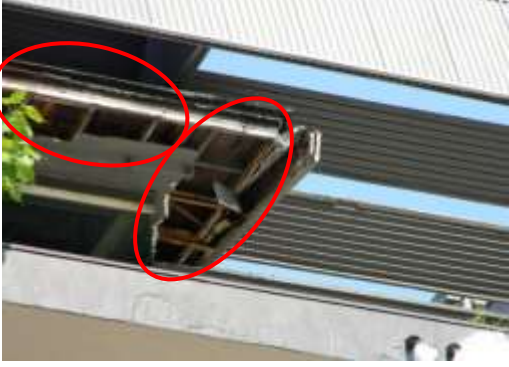
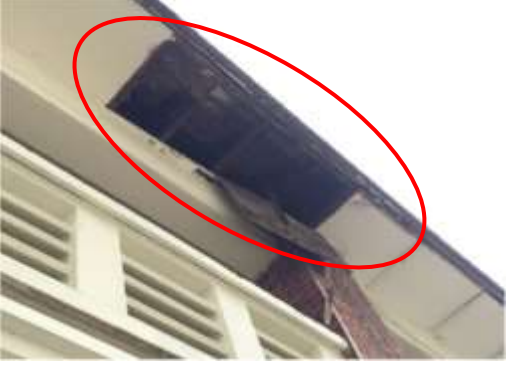
<p>Degraded and dangling external ceiling panels [Source: BCA file]</p>	<p>Dangling board [Source: BCA file]</p>

Exterior false ceilings are prone to occasional wetting due to rain. Through the investigation on cases involving dislodgement and fallen exterior false ceiling panels (e.g. calcium silicate boards), it was found that failure of the connecting anchors due to spalling concrete, deterioration of board materials, and corrosion of supporting frames are the common causes for exterior suspended ceiling system. Therefore, the Competent Person shall either remove the false ceiling panel or adopt technology to carry out thorough inspection on the concealed supporting system. The integrity and condition of the ceiling system shall be indicated in the inspection report.

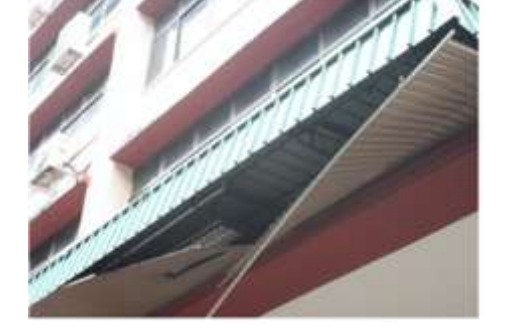
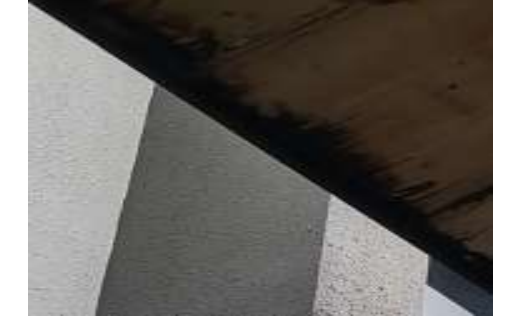
<p>Dangling metal false ceiling [Source: BCA file]</p>	<p>Moulding on external ceiling board [Source: BCA file]</p>

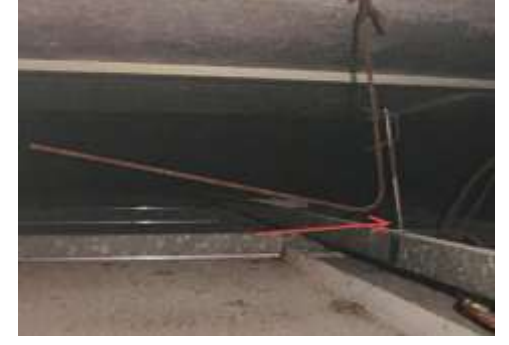
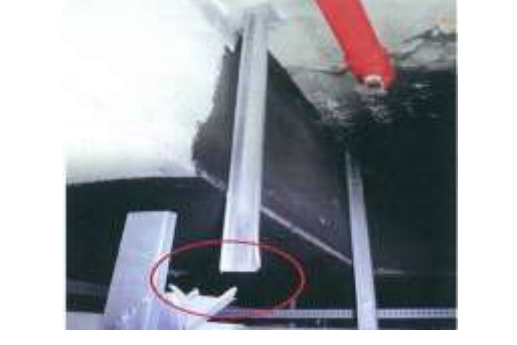
<p>Corroded hanging rod supporting ceiling sub frame [Source: BCA file]</p>	<p>Broken hanging rod supporting ceiling sub frame [Source: local consultant]</p>

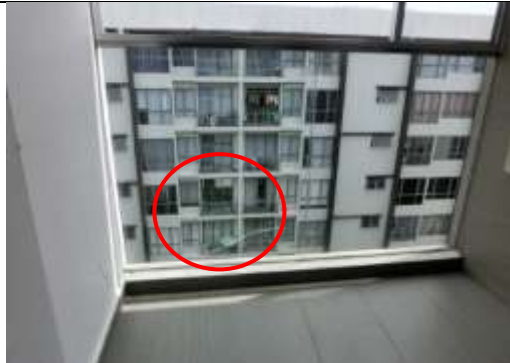
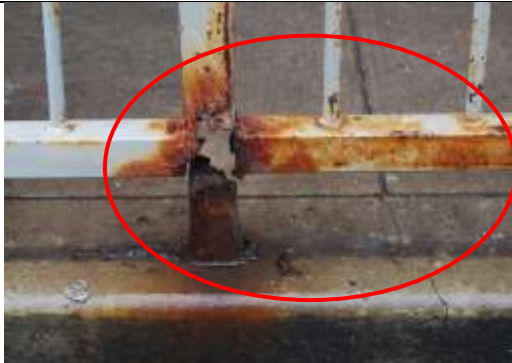
Cracked glass panels [Source: BCA file]	Corroded railing supports [Source: <a href="http://www.imageworkspainting.com">www.imageworkspainting.com</a> ]

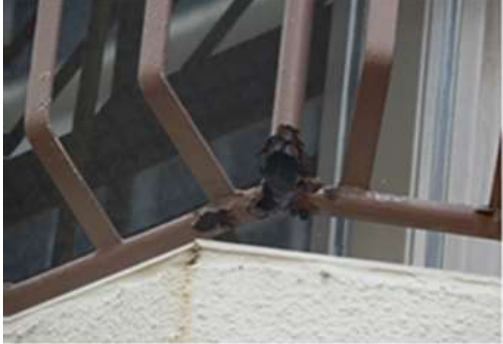
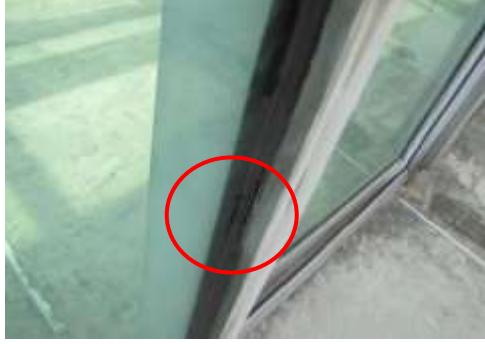
<p>Corroded metal railing [Source: BCA file]</p>	<p>Damaged sealant [Source: BCA file]</p>

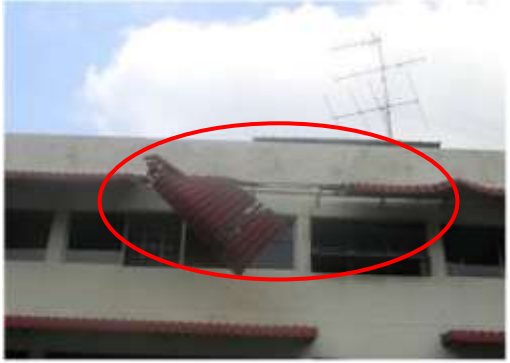
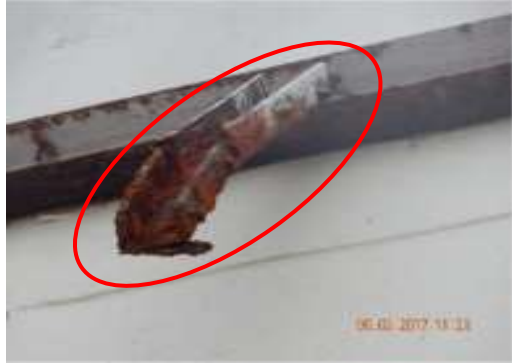
<p>Detached awning [Source: BCA file]</p>	<p>Corroded sunshade support [Source: BCA file]</p>

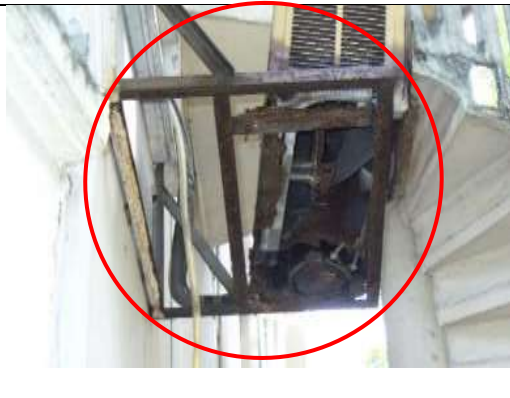
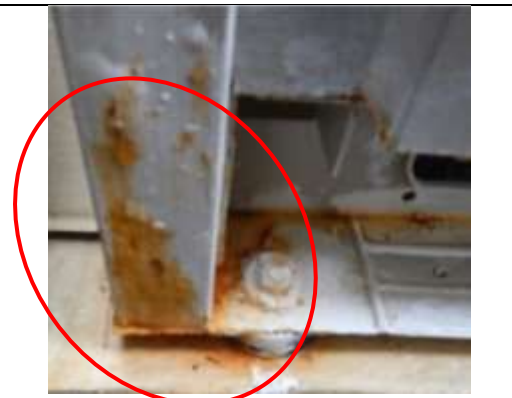
<p>Corroded air-con bracket [Source: BCA file]</p>	<p>Corroded fixing [Source: www.daikin.com/anti-corrosion]</p>

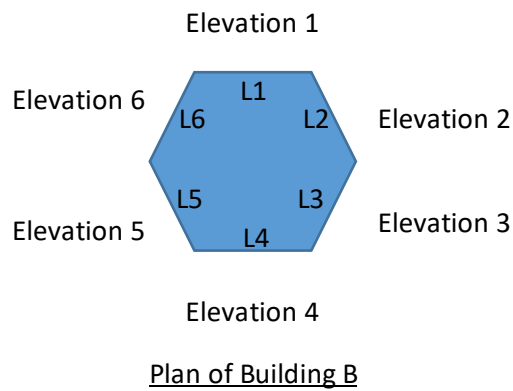
Example 2

Building B, with a total height of H, has a hexagonal plan and 6 façade elevations.

The minimum coverage of the “Close-range” inspection shall be as follows:-

- Elevation 1 – 10% of  $(L1 \cdot H)$  m<sup>2</sup>
- Elevation 2 – 10% of  $(L2 \cdot H)$  m<sup>2</sup>
- Elevation 3 – 10% of  $(L3 \cdot H)$  m<sup>2</sup>
- Elevation 4 – 10% of  $(L4 \cdot H)$  m<sup>2</sup>
- Elevation 5 – 10% of  $(L5 \cdot H)$  m<sup>2</sup>
- Elevation 6 – 10% of  $(L6 \cdot H)$  m<sup>2</sup>
